RAIL TRAGEDY A DISASTER WAITING TO HAPPEN

The Hualien, Taiwan, derailment early this month that caused 49 deaths and some 200 injuries serves to remind us of the importance of ensuring safety in public transport.

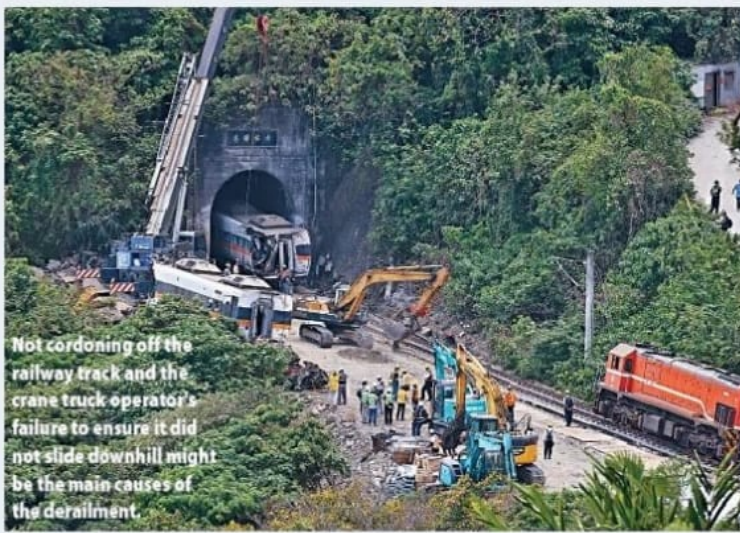
Not cordoning off the railway track and the crane truck operator's failure to ensure it did not slide downhill might be the main causes of the derailment.

In this instance, the construction lorry that traversed the track might not have had metal parts touching both rails, and therefore the railway signaling system could not detect it.

When the lorry that got stuck on the track came into view of the train driver, there would not have been enough time to brake the long and heavy train.

That a construction vehicle could enter the site on a public holiday morning, presumably without approval or supervision, was certainly a major breach and must have been a cause of the accident.

Further to that, all drivers were taught to always leave vehicles in gear when parked, before firmly applying the handbrake—a vital move to prevent them from rolling down a slope. For that lorry to have been able to roll downhill to land on the track, it must have been left in neutral gear. Such negligence would have been another main cause of this catastrophe.

For electric railway systems, the area near the track should be protected by barriers. That does not only mean the immediate vicinity but should include some 30 meters of the surrounding area.

All construction and maintenance work near this area must be approved and monitored by the railway operator to ensure no safety threats.
