# City Talk

## HOW THE CITY AVOIDS MEXICAN DISASTERS

### Nuts and bolts

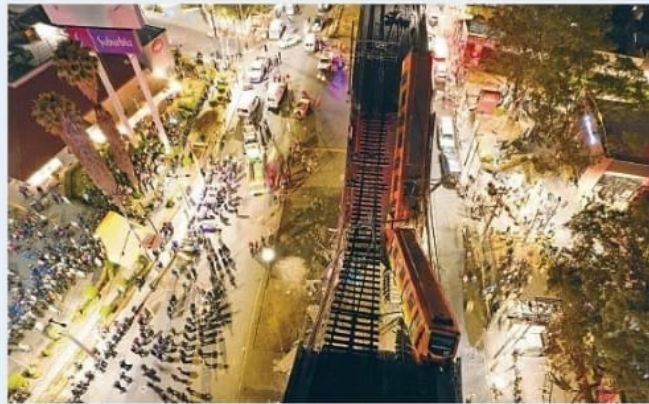
The Mexico City train overpass collapse fueled outrage and demands for a probe.

According to pictures of the accident scene, the two adjacent columns remain intact.

It also showed that the column's bifurcation (the point where the railway line begins splitting into two lines to allow trains to travel two different routes) suffered more damage.

That half of the beam had dislodged from the rail and fell to the ground, while the other half of the beam was still supported on the other column.

What is not certain is whether the critical failure first occurred at that column support or at the midspan of the bridge.

We suspect that it could be a design defect or issues with the construction quality.

It could even be that the beam was designed and constructed appropriately, but suffered damage during an earthquake, and the subsequent inspection and repair work was inadequate.
