SHIP FIRE TO FUEL SEA CHANGE IN CAR CARRIERS

Nuts and bolts

Veteran engineer Edmund Leung Kwong-ho casts an expert eye over features of modern life

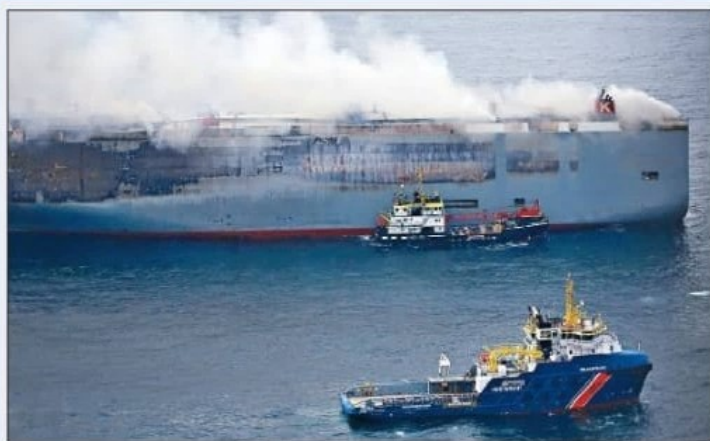
Photos show a large opening at the side of the ship, damaged by the immense heat penetration.
